Cherokee High School
Lenape Regional High School District

Cherokee – Turf Evaluation

February 26, 2019

Re: Fiber Wear Evaluation Report For Cherokee High School Turf Field

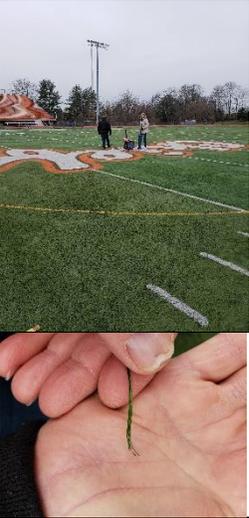
<p>C</p>	<p>Center Area: The green turf around the fifty-yard line (football) was worn as described previously as were the Inlays.</p> <p>For review by Hans J. Kolitzus - two typical defective sections of about 1 sft (13" by 13" square, sideline sample was larger). The 1st sample taken around the 45 southeastern yard line and the 2nd sample near midfield, along the edge adjacent to the track on the Home side of the stadium.</p>

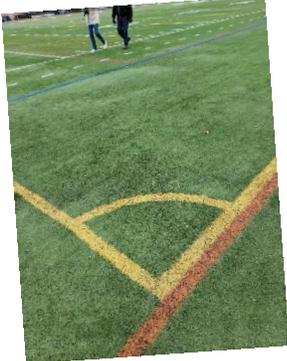
<p>PK</p>	<p>Penalty Kick: Same condition as above (Note: Picture from northeast corner of the field). These areas appeared more compacted with fiber on their side.</p>
